Advanced Condition Assessment of Hunter Water's Cast Iron Watermains

Matthew Dafter, Hunter Water Australia, PhD Candidate University of Newcastle

Robert Petersen, Research Associate, University of Newcastle

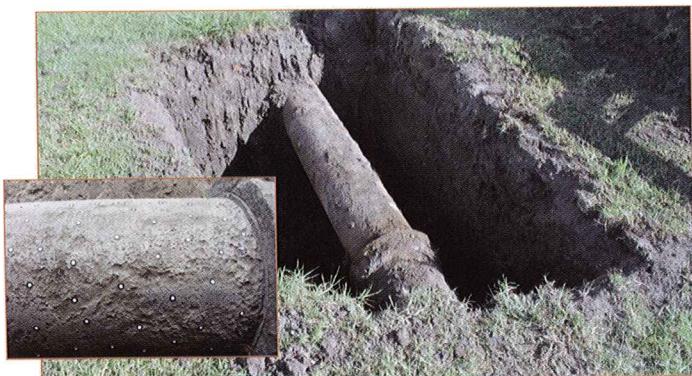
Site 1 – WS4 – WS4 is a DN 375 cast iron (CI) pipe located adjacent to a stormwater channel in Broadmeadow, NSW (Figure 1). The soil at this site was classified as sandy clay with moisture content of 16.2%. While the water table was not noticeable on site, exhumation

revealed that the pipe was propped up on stone and hardwood, indicating that the ground conditions at installation may have been significantly wetter than those observed in 2013. Also of note was the presence of coal and other assorted contaminants within the soil profile at this site. Sample WS4 was actually first identified as a DN 375 cement lined cast iron (CICL) pipe installed in 1972, however upon exhumation, the pipe was actually revealed to have been installed in 1884. The error was likely due to an error in the digitisation of the paper records. The results of the 3D laser scanning on WS4 (see Figures 2 and 3) highlight that for a pipe nearing 130 years of service, this asset is in excellent condition with a maximum pit depth of 7.5 mm (measured manually). The corrosion on this pipe was mostly observed at the 3 and 9 o'clock positions and was present as large areas of general corrosion, as opposed to highly localised attack.

Figure 1: WS4 before abrasive blasting and the sites of maximum corrosion loss after abrasive blasting (inset).

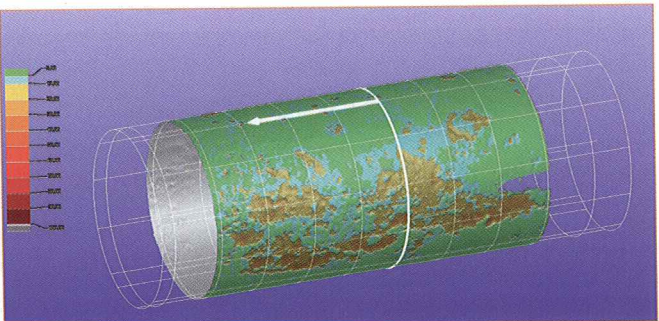
during the 1950's. The design thickness of these pipes was actually cast into the pipe (¾ cast onto socket) and in this case, each pipe is likely to be around 18 mm thick (although other sections of this pipe are known to be up to 23mm thick). Assuming a regular wall thickness, this represents a maximum corrosion penetration of around 42% of the original wall, and a linear corrosion loss of around 0.06 mm/yr. It would not be unreasonable to suggest a probable life in excess of 250 years based on this simple analysis for a pipe such as this in these soil conditions. This of course assumes that no internal corrosion has occurred, which is unlikely on a pipe that was not internally lined for around 65 years.

Figure 2: 3D scan results for pipe WS4; most corrosion at this site was located roughly at the springline (horizontal).

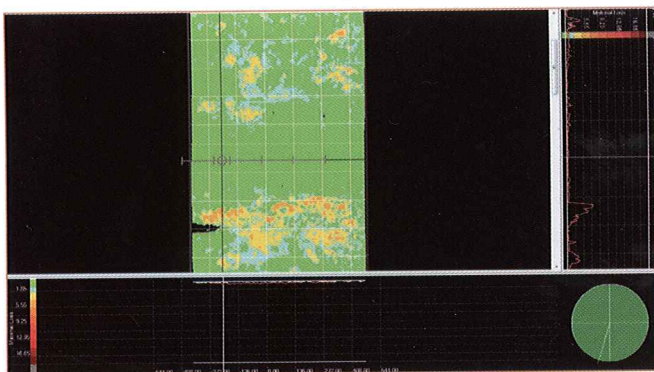
Figure 3 – 2D representation of the data presented in figure 2.

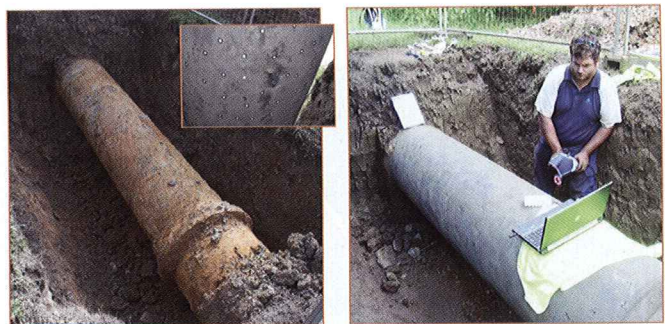
Figure 4: WS5 prior to abrasive blasting (inset – corrosion on bottom of pipe after abrasive blasting).

Figure 5: WS5 during the scanning process, this took approximately 1.5 hours on this 600mm pipe.

that the recorded install date is consistent with the pipe details. Figures 4 and 5 show this pipe before and after the abrasive blasting. The inset in Figure 4 shows a close-up photograph of the deepest region of corrosion, which was located on the underside of the pipe. This pipe was also found to be in good condition for its age. Corrosion losses at this site were largely non-existent. A single significant corrosion site, located directly on the underside of the pipe (see Figures 6 and 7 and the inset in Figure 4), was measured to have a pit depth of around 10mm (9.2mm manually and 10.5mm using the laser scanner software). This represents a corrosion loss of around 47% of the original wall thickness, although again it should be stressed that the wall thickness of a vertically cast iron pipe such as this can vary by a significant amount, both in the circumferential and axial directions.

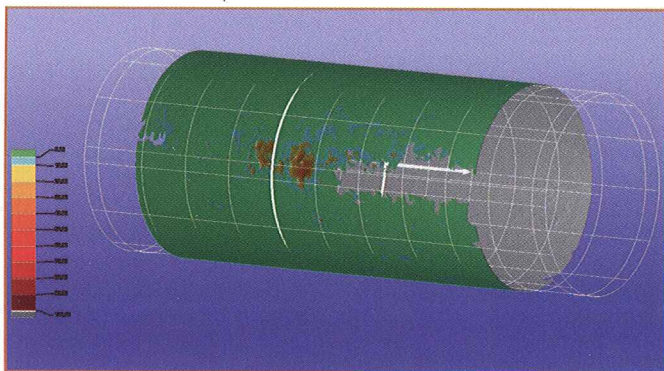
Figure 6: 3D scan of sample WS5, virtually no corrosion was observed except for the 2-3 localised sites of general attack.

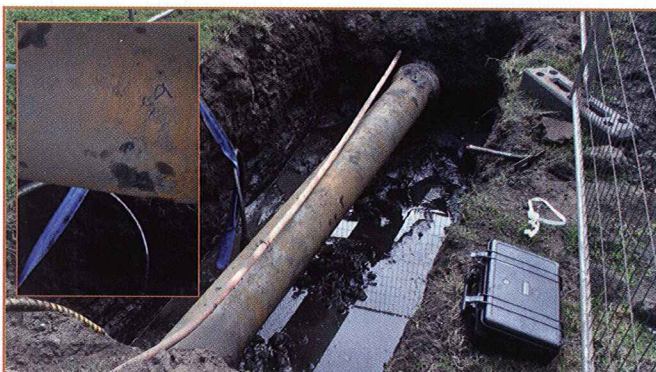
Site 3 MC4 – sample MC4 is located in Mayfield, NSW (see Figure 8) and the site conditions were entirely different from those seen at sites 1 and 2. Located adjacent to a small natural creek the water table at this site was touching the bottom of this pipe. Natural variation in the water table would suggest that for at least small portions of the year, this pipe is partially submerged. The soil at this site was notable for its high moisture

content (23.4%) and relatively high levels of organic carbon. The pipe at this site was a DN 300 CIGL pipe installed in 1967. Of note at this site was the lack of a selected backfill; the use of selected backfill was adopted in the Hunter region in the early 1960's, and was used sporadically until the early 1980's, when its use became common practise with the introduction of Ductile Iron pipes. Large aggregate was present within the soil matrix and may be a remnant of the installation process.

Laser scanning of this site was conducted, however scanning was limited to the top 85% or so of the pipe because of the local water table (see Figures 8 and 9). At the base of the pipe, manual corrosion measurements were taken. The corrosion observed at this site is entirely different from that observed at sites 1 and 2. In this case, many small, well-formed circular pits were identified. The depth of these pits increased almost linearly, from around 3-4 mm near the top of the pipe to 6.5mm towards the bottom.

Figure 8: MC4 after abrasive blasting (inset – close up of deepest pit on underside of pipe).

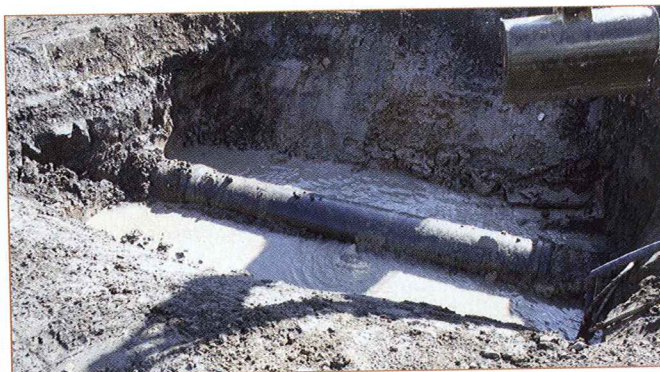
Prediction of failures on underground assets such as this failed DN 500 cast iron pipe are the significant driver of this research.

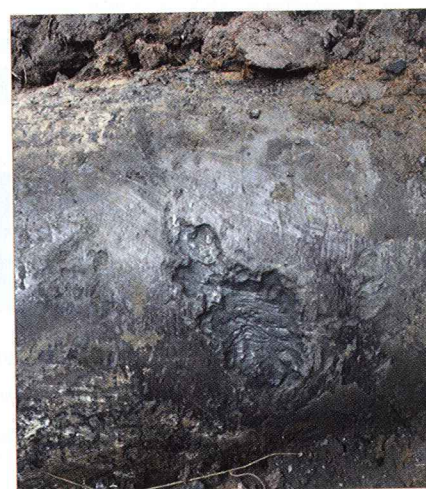
Mechanical removal of graphitised zone in a corroded cast iron pipe.
